**Flood Control Project Maintenance
Levee Inspections**

2018 Channel Summary Report

Merced Streams Group

Levee Inspection Report By Mile - Channel 2018

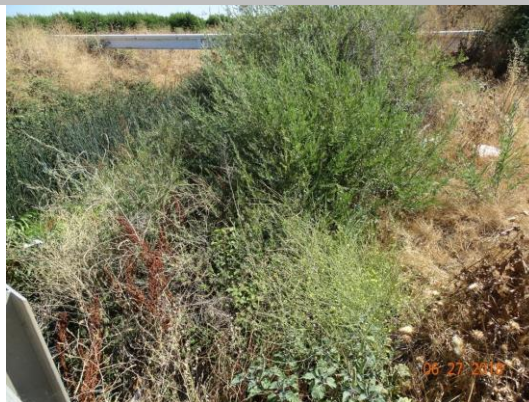
Photo 2 of 3 : CH_2018_NA0013_36_16_20180713_00079.jpg

Rating **	M	Issue No.	16	GPS Lat/Long
Issue Type +	Ma	Location *		37.284393 °
Category	Rivers, Channels & Designated Flood			-120.315460 °
Item	Vegetation & Obstructions			
DWR ID	DWR_NA0013_36_c_2012_16			
Action/Comments				
Inspector Comments: Woody vegetation may impede flow in the future and should be cleared at least 100 feet downstream.

View of vegetation in the channel. Summer 2018

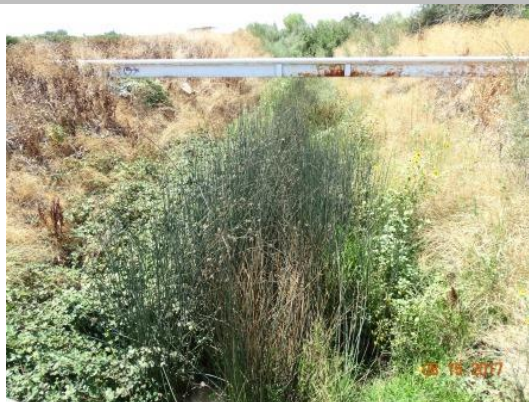
Photo 3 of 3 : CH_2018_NA0013_36_16_20180608_00004.jpg

Rating **	M	Issue No.	16 (cont)	GPS Lat/Long
Issue Type +	Ma	Location *		37.284393 °
Category	Rivers, Channels & Designated Flood			-120.315460 °
Item	Vegetation & Obstructions			
DWR ID	DWR_NA0013_36_c_2012_16			
Action/Comments				
Inspector Comments: Woody vegetation may impede flow in the future and should be cleared at least 100 feet downstream.

Santa Fe Dr. crossing downstream view. Summer 2017

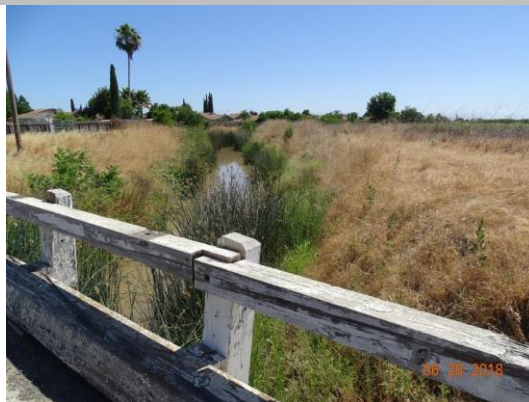
Photo 1 of 2 : CH_2018_NA0013_36_21_20180712_00038.jpg

Rating **	A	Issue No.	21	GPS Lat/Long
Issue Type +	Ma	Location *		37.282285 °
Category	Rivers, Channels & Designated Flood			-120.324890 °
Item	Vegetation & Obstructions			
DWR ID	DWR_NA0013_36_c _ 2012_21			
Action/Comments				
Inspector Comments: There is minor vegetation that does not appear to impede flow.

View of vegetation in the channel. Summer 2018

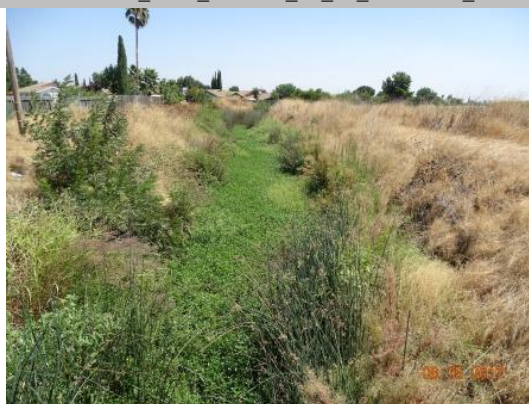
Photo 2 of 2 : CH_2018_NA0013_36_21_20180608_00005.jpg

Rating **	A	Issue No.	21 (cont)	GPS Lat/Long
Issue Type +	Ma	Location *		37.282285 °
Category	Rivers, Channels & Designated Flood			-120.324890 °
Item	Vegetation & Obstructions			
DWR ID	DWR_NA0013_36_c_2012_21			
Action/Comments				
Inspector Comments: There is minor vegetation that does not appear to impede flow.

Plainsburg Road crossing upstream view. Summer 2017

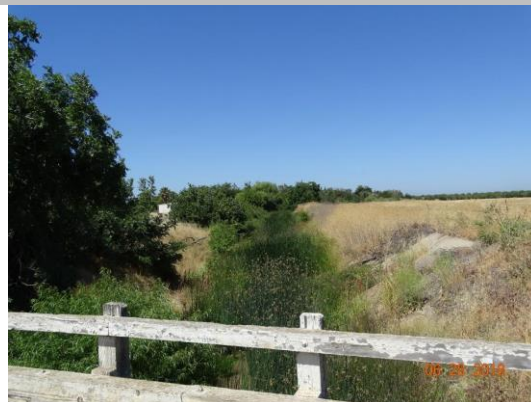
Photo 1 of 3 : CH_2018_NA0013_36_26_20180712_00039.jpg

Rating **	A	Issue No.	26	GPS Lat/Long
Issue Type +	Ma	Location *		37.282060 °
Category	Rivers, Channels & Designated Flood			-120.324870 °
Item	Vegetation & Obstructions			
DWR ID	DWR_NA0013_36_c_2012_26			
Action/Comments				
Inspector Comments: Vegetation in the channel should be maintained to prevent a reduction in channel capacity.

View of vegetation in channel. Summer 2018

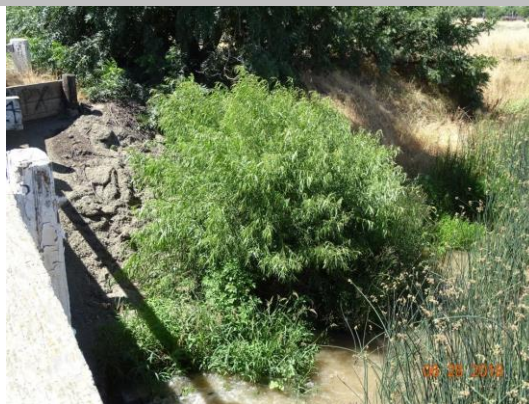
Photo 2 of 3 : CH_2018_NA0013_36_26_20180712_00040.jpg

Inspector Comments: Vegetation in the channel should be maintained to prevent a reduction in channel capacity.

View of vegetation along left bank. Summer 2018

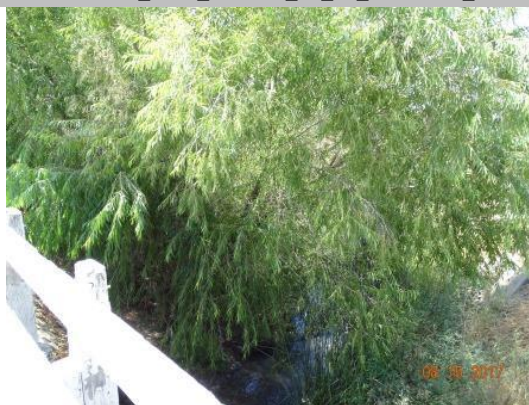
Photo 3 of 3 : CH_2018_NA0013_36_26_20180608_00006.jpg

Plainsburg Rd crossing, downstream view, Note woody vegetation on left side of channel. Summer 2017

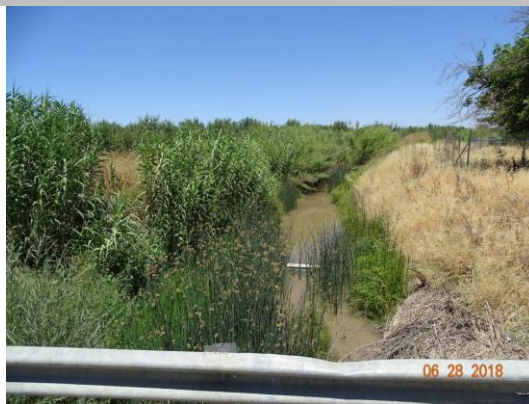
Photo 1 of 3 : CH_2018_NA0013_36_31_20180712_00042.jpg

View of vegetation in the channel. Summer 2018

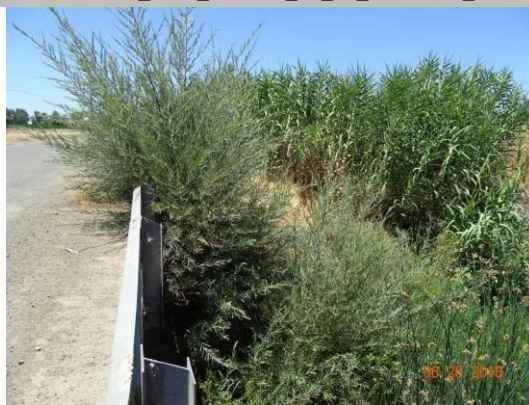
Photo 2 of 3 : CH_2018_NA0013_36_31_20180712_00041.jpg

View of vegetation growing underneath crossing. Summer 2018

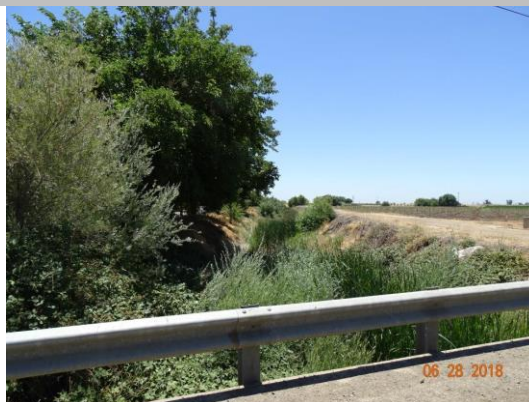
Photo 1 of 2 : CH_2018_NA0013_36_36_20180712_00043.jpg

Rating **	M	Issue No.	36	GPS Lat/Long
Issue Type +	Ma	Location *		37.280720 °
Category	Rivers, Channels & Designated Flood			-120.331200 °
Item	Vegetation & Obstructions			
DWR ID	DWR_NA0013_36_c_2012_36			
Action/Comments				
Inspector Comments: Vegetation may impede flow and needs to be cleared.

View of vegetation in the channel. Summer 2018

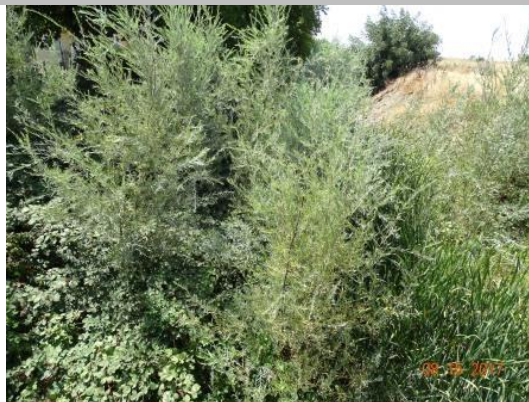
Photo 2 of 2 : CH_2018_NA0013_36_36_20180608_00008.jpg

Downstream view from Gerard Ave. crossing. Summer 2017

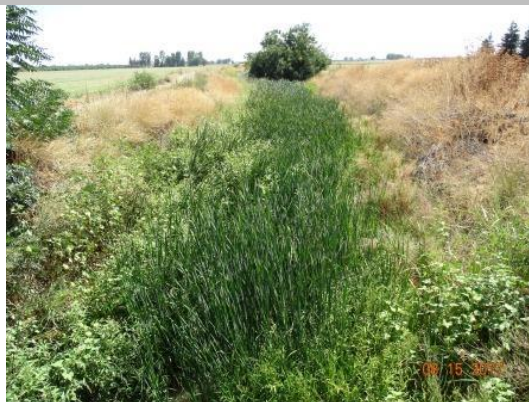
Photo 2 of 2 : CH_2018_NA0013_36_41_20180608_00009.jpg

Rating **	M	Issue No.	41	GPS Lat/Long
Issue Type +	Ma	Location *		37.278630 °
Category	Rivers, Channels & Designated Flood			-120.343030 °
Item	Vegetation & Obstructions			
DWR ID	DWR_NA0013_36_c_2012_41			
Action/Comments				
Inspector Comments: Vegetation in the channel may impede flow. Recommend clearing at least 100 feet upstream.

Upstream view from Whealan Rd. crossing. Summer 2017

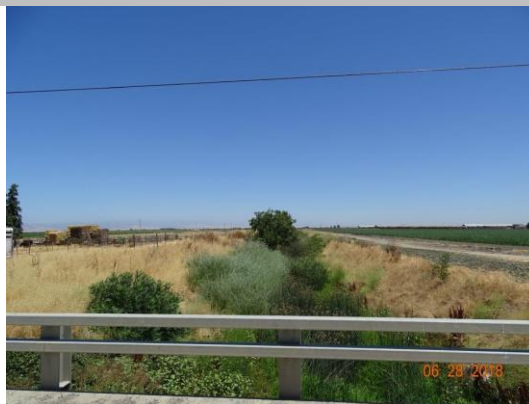
Photo 1 of 3 : CH_2018_NA0013_36_51_20180712_00046.jpg

Rating **	M	Issue No.	51 (cont)	GPS Lat/Long
Issue Type +	Ma	Location *		37.272977 °
Category	Rivers, Channels & Designated Flood			-120.379054 °
Item	Vegetation & Obstructions			
DWR ID	DWR_NA0013_36_c_2012_51

View of vegetation in the channel. Summer 2018

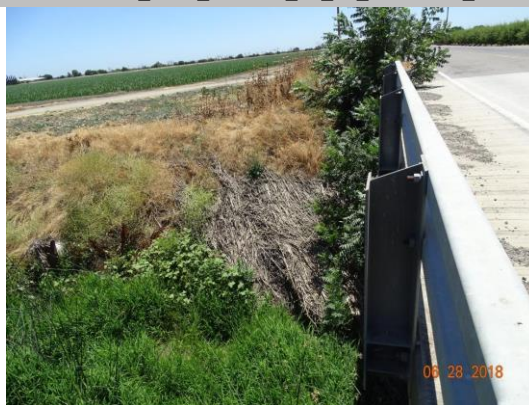
Photo 2 of 3 : CH_2018_NA0013_36_51_20180712_00047.jpg

View of dead vegetation near the bridge. Summer 2018

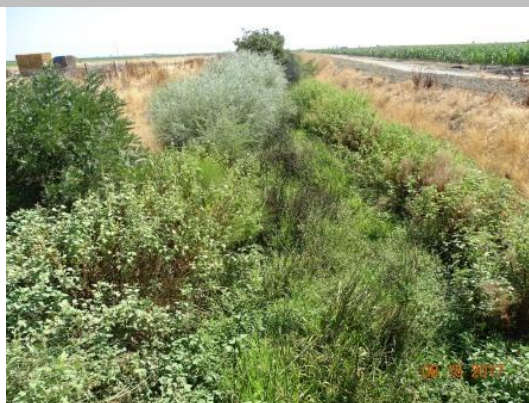
Photo 3 of 3 : CH_2018_NA0013_36_51_20180608_00011.jpg

Upstream view from Arboleda Dr. crossing. Summer 2017

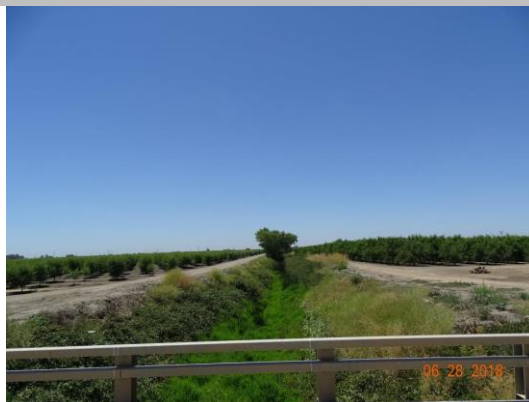
Photo 1 of 3 : CH_2018_NA0013_36_56_20180712_00048.jpg

Rating **	A	Issue No.	56	GPS Lat/Long
Issue Type +	Ma	Location *		37.272977 °
Category	Rivers, Channels & Designated Flood			-120.379050 °
Item	Vegetation & Obstructions			
DWR ID	DWR_NA0013_36_c_2012_56			
Action/Comments				
Inspector Comments: Minor vegetation does not appear to impede flow.

View of vegetation in the channel. Summer 2018

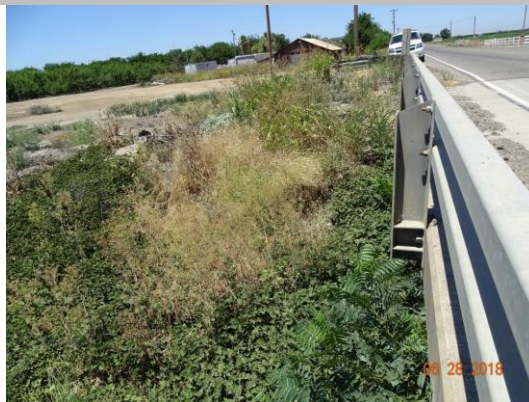
Photo 2 of 3 : CH_2018_NA0013_36_56_20180712_00049.jpg

View of vegetation adjacent to bridge. Summer 2018

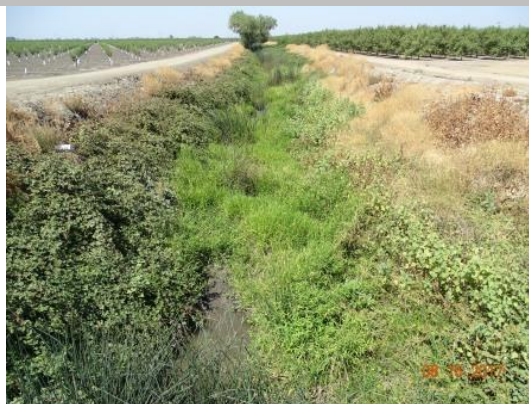
Photo 3 of 3 : CH_2018_NA0013_36_56_20180608_00013.jpg

Inspector Comments: Minor vegetation does not appear to impede flow.

Downstream view from Arboleda Dr. crossing. Summer 2017

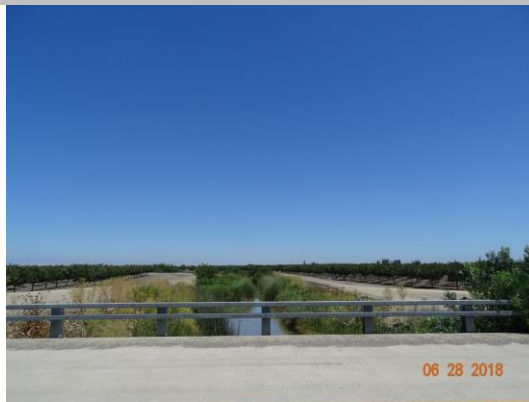
Photo 1 of 3 : CH_2018_NA0013_36_61_20180712_00050.jpg

Rating **	A	Issue No.	61	GPS Lat/Long
Issue Type +	Ma	Location *		37.269380 °
Category	Rivers, Channels & Designated Flood			-120.397470 °
Item	Vegetation & Obstructions			
DWR ID	DWR_NA0013_36_c_2014_61			
Action/Comments				
Inspector Comments: Vegetation next to bridge may impede flow in the future and needs to be controlled.

View of vegetation in the channel. Summer 2018

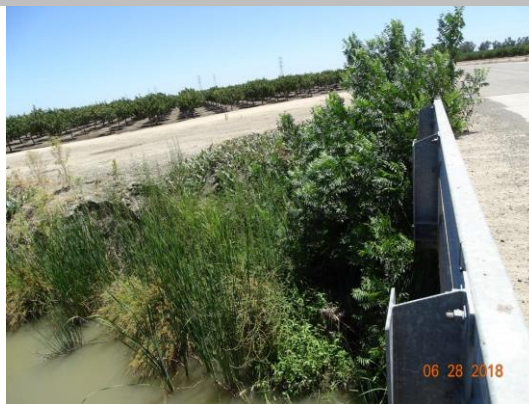
Photo 2 of 3 : CH_2018_NA0013_36_61_20180712_00051.jpg

Inspector Comments: Vegetation next to bridge may impede flow in the future and needs to be controlled.

View of vegetation encroaching onto bridge. Summer 2018

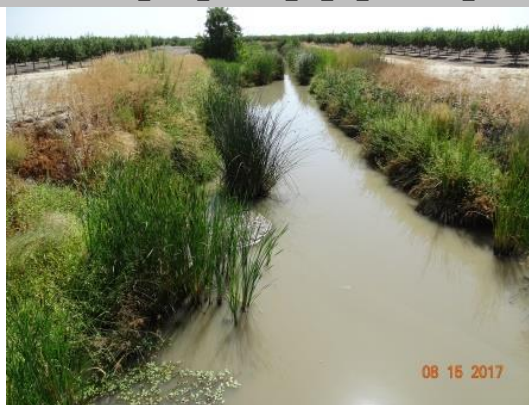
Photo 3 of 3 : CH_2018_NA0013_36_61_20180608_00014.jpg

Upstream view from Orchard Rd. crossing. Summer 2017

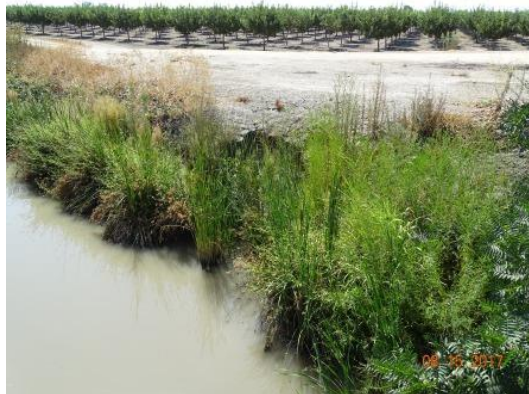
Photo 1 of 1 : CH_2018_NA0013_36_63_20180608_00015.jpg

Inspector Comments: Erosion on the left bank does not appear to endanger the channel.

View of the erosion in the channel. Summer 2017

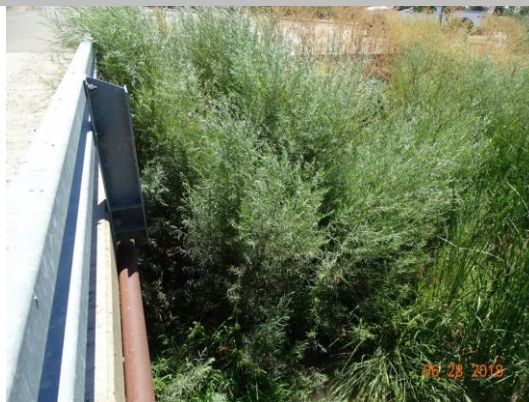
Photo 2 of 3 : CH_2018_NA0013_36_66_20180712_00054.jpg

Rating **	U	Issue No.	66	GPS Lat/Long
Issue Type +	Ma	Location *		37.269380 °
Category	Rivers, Channels & Designated Flood			-120.397470 °
Item	Vegetation & Obstructions			
DWR ID	DWR_NA0013_36_c_2012_66			
Action/Comments				
Inspector Comments: excessive vegetation and arundo may impede flow and should be cleared at least 100 feet downstream.

View of vegetation adjacent to the bridge. Summer 2018

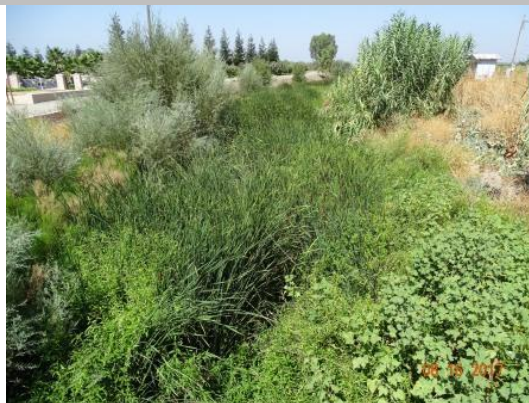
Photo 3 of 3 : CH_2018_NA0013_36_66_20180608_00016.jpg

Downstream view from Orchard Rd. crossing. Summer 2017

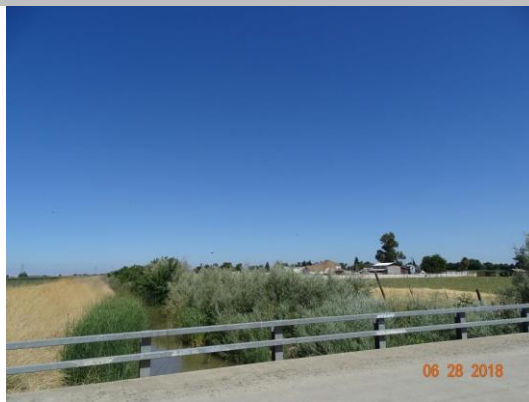
Photo 1 of 3 : CH_2018_NA0013_36_111_20180713_00072.jpg

Rating **	M	Issue No.	111	GPS Lat/Long
Issue Type +	Ma	Location *		37.267185 °
Category	Rivers, Channels & Designated Flood			-120.415332 °
Item	Vegetation & Obstructions			
DWR ID	DWR_NA0013_36_c_2013_111			
Action/Comments				
Inspector Comments: Woody vegetation on the left bank may impede flow and should be cleared at least 100 feet upstream.

View of vegetation in the channel. Summer 2018

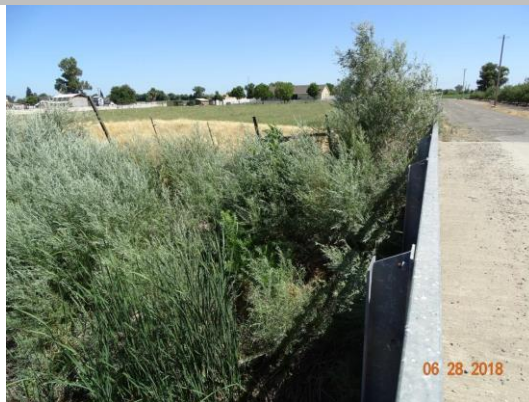
Photo 2 of 3 : CH_2018_NA0013_36_111_20180713_00073.jpg

View of vegetation growing near bridge. Summer 2018

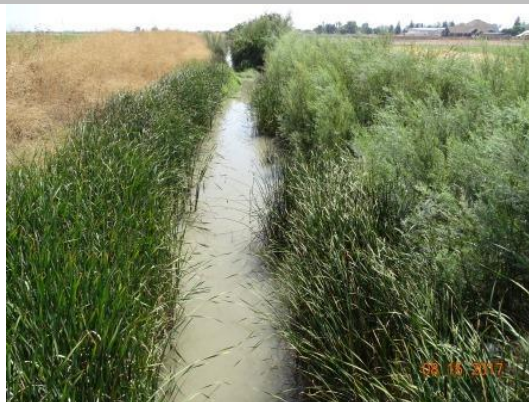
Photo 3 of 3 : CH_2018_NA0013_36_111_20180608_00029.jpg

Inspector Comments: Woody vegetation on the left bank may impede flow and should be cleared at least 100 feet upstream.

Upstream view of Miles Creek from Miles Road. Summer 2017

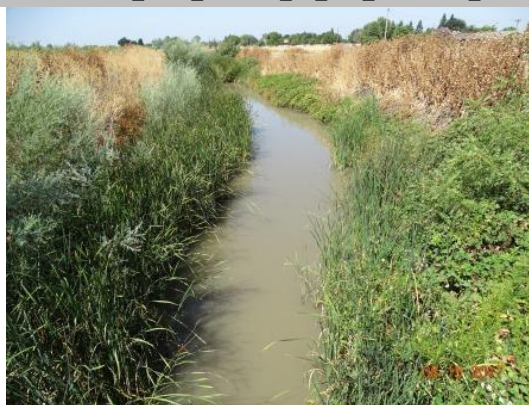
Photo 3 of 3 : CH_2018_NA0013_36_116_20180608_00030.jpg

Inspector Comments: Woody vegetation on the left bank needs removal, recommend that it be cleared at least 100 feet downstream.

Downstream view of Miles Creek from Miles Road. Summer 2017

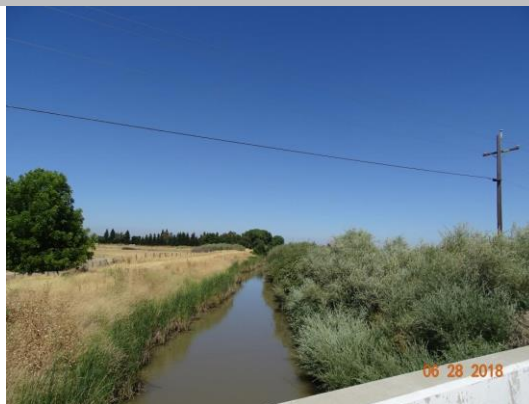
Photo 1 of 2 : CH_2018_NA0013_36_121_20180713_00076.jpg

Inspector Comments: Woody vegetation on the left bank may impede flow in the future and should be controlled.

View of vegetation in the channel. Summer 2018

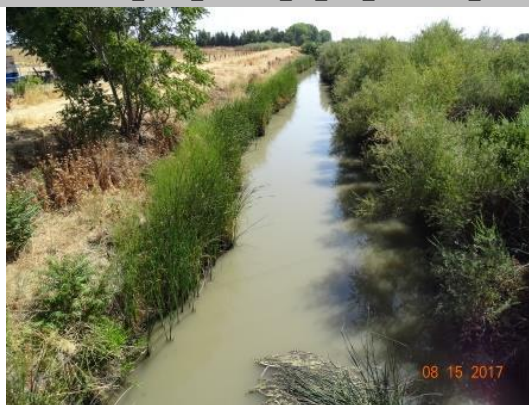
Photo 2 of 2 : CH_2018_NA0013_36_121_20180608_00031.jpg

Upstream view of Miles Creek from Coffee St. Summer 2017

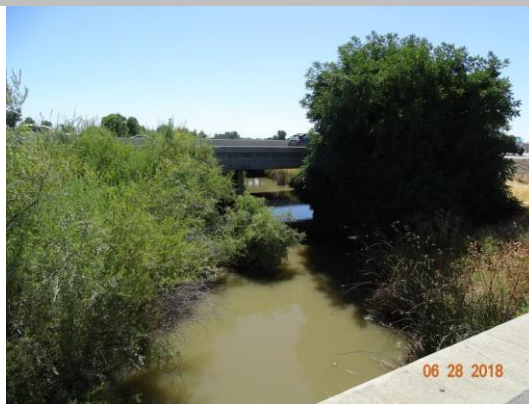
Photo 1 of 3 : CH_2018_NA0013_36_126_20180713_00077.jpg

View of vegetation along the channel. Summer 2018

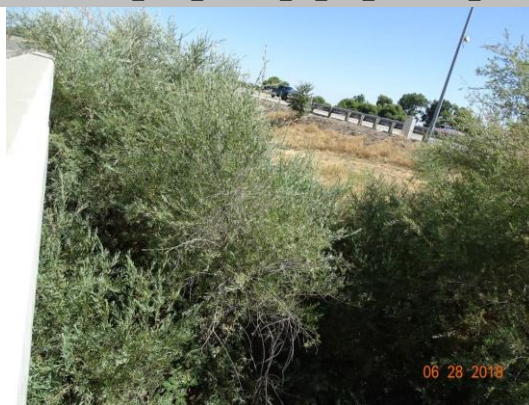
Photo 2 of 3 : CH_2018_NA0013_36_126_20180713_00078.jpg

View of vegetation adjacent to the bridge. Summer 2018

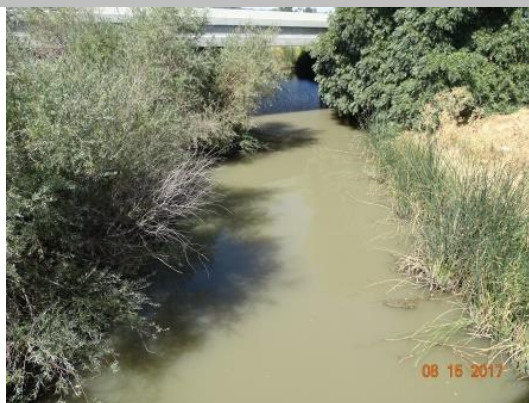
Photo 3 of 3 : CH_2018_NA0013_36_126_20180608_00032.jpg

Downstream view of Miles Creek from Coffee St. Summer 2017

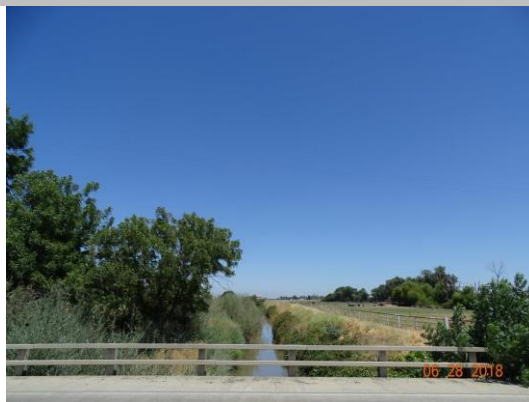
Photo 1 of 2 : CH_2018_NA0013_36_71_20180712_00055.jpg

Rating **	M	Issue No.	71	GPS Lat/Long
Issue Type +	Ma	Location *		37.263590 °
Category	Rivers, Channels & Designated Flood			-120.434500 °
Item	Vegetation & Obstructions			
DWR ID	DWR_NA0013_36_c_2012_71			
Action/Comments				
Inspector Comments: Woody vegetation in the channel may impede flow and should be cleared at least 100 feet upstream.

View of vegetation in the channel and growth onto bridge. Summer 2018

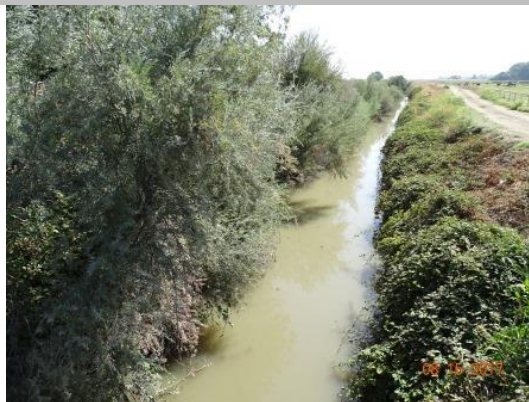
Photo 2 of 2 : CH_2018_NA0013_36_71_20180608_00017.jpg

Upstream view of Miles Creek from Healy Rd. crossing. Summer 2017

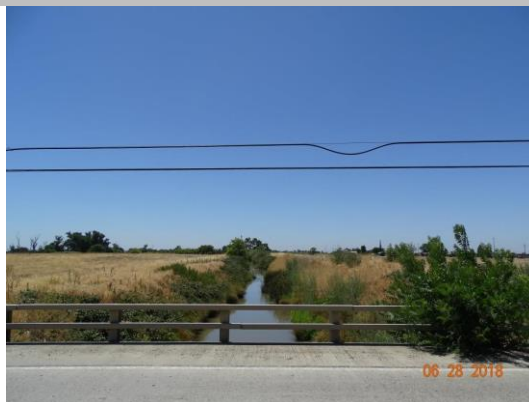
Photo 1 of 3 : CH_2018_NA0013_36_76_20180712_00056.jpg

Rating **	A	Issue No.	76	GPS Lat/Long
Issue Type +	Ma	Location *		37.263590 °
Category	Rivers, Channels & Designated Flood			-120.434500 °
Item	Vegetation & Obstructions			
DWR ID	DWR_NA0013_36_c_2012_76			
Action/Comments				
Inspector Comments: There is vegetation in the channel, but it doesn't appear to impede channel capacity at this time.

View of vegetation in the channel and on the bridge. Summer 2018

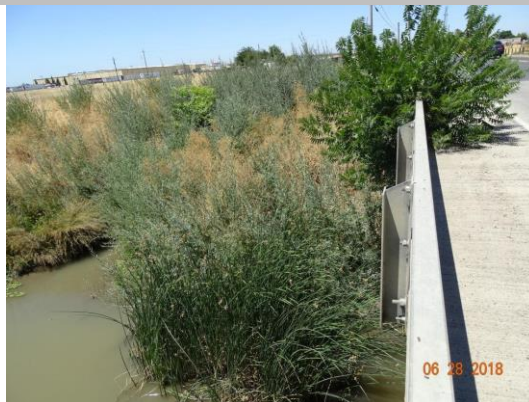
Photo 2 of 3 : CH_2018_NA0013_36_76_20180712_00057.jpg

View of vegetation in the channel and on the bridge. Summer 2018

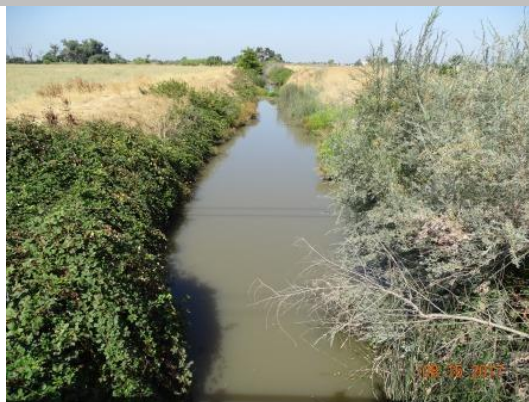
Photo 3 of 3 : CH_2018_NA0013_36_76_20180608_00018.jpg

Inspector Comments: There is vegetation in the channel, but it doesn't appear to impede channel capacity at this time.

Downstream view of Miles Creek from Healy Rd. crossing. Summer 2017

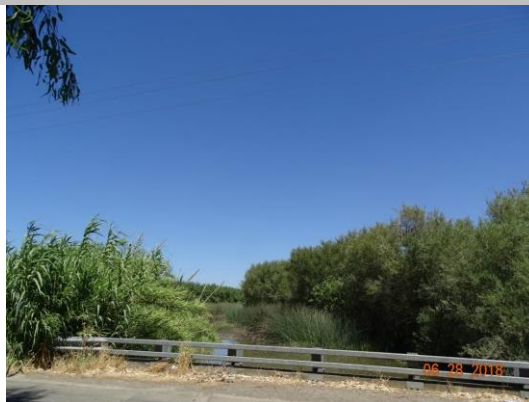
Photo 1 of 3 : CH_2018_NA0013_36_81_20180712_00058.jpg

Rating **	M	Issue No.	81	GPS Lat/Long
Issue Type +	Ma	Location *		37.263560 °
Category	Rivers, Channels & Designated Flood			-120.469660 °
Item	Vegetation & Obstructions			
DWR ID	DWR_NA0013_36_c_2012_81			
Action/Comments				
Inspector Comments: Minor vegetation, but does not appear to be enough to impede flow. Arundo needs to be controlled.

View of vegetation along the channel. Summer 2018

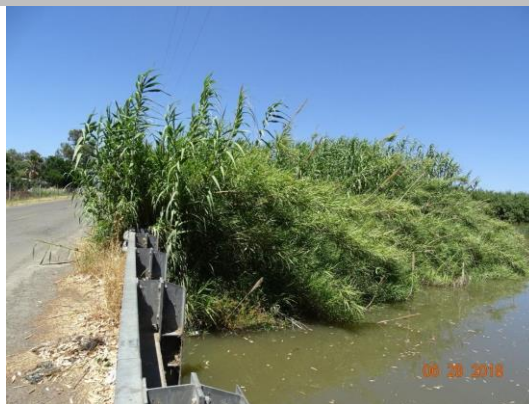
Photo 2 of 3 : CH_2018_NA0013_36_81_20180712_00059.jpg

Inspector Comments: Minor vegetation, but does not appear to be enough to impede flow. Arundo needs to be controlled.

View of Arundo encroaching onto bridge. Summer 2018

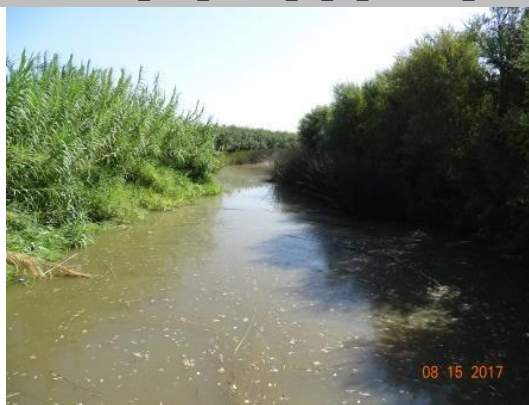
Photo 3 of 3 : CH_2018_NA0013_36_81_20180608_00019.jpg

Upstream view of Miles Creek from Tyler Rd. crossing. Summer 2017

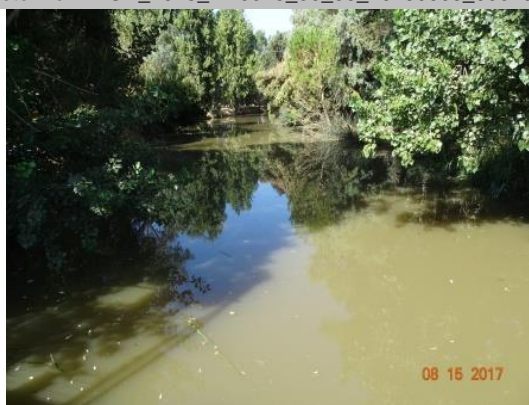
Photo 2 of 2 : CH_2018_NA0013_36_86_20180608_00020.jpg

Rating **	A	Issue No.	86	GPS Lat/Long
Issue Type +	Ma	Location *		37.263658 °
Category	Rivers, Channels & Designated Flood			-120.469770 °
Item	Vegetation & Obstructions			
DWR ID	DWR_NA0013_36_c_2012_86			
Action/Comments				
Inspector Comments: Minor vegetation, but does not appear to be enough to impede flow.

Downstream view of Miles Creek from Tyler Rd. crossing. Summer 2017

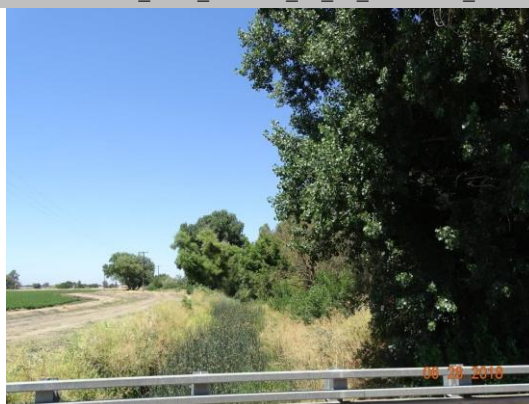
Photo 1 of 2 : CH_2018_NA0013_36_91_20180712_00063.jpg

Inspector Comments: Vegetation in the channel may impede flow and should be cleared.

View of vegetation in the channel. Summer 2018

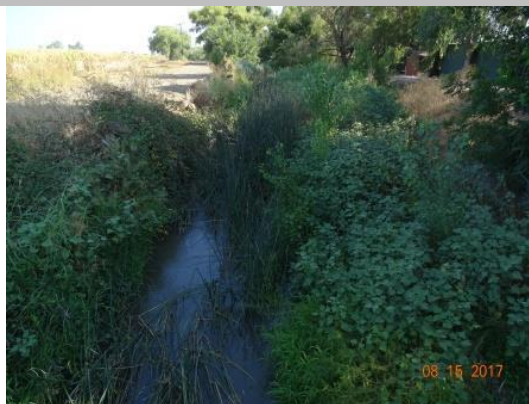
Photo 2 of 2 : CH_2018_NA0013_36_91_20180608_00023.jpg

Inspector Comments: Vegetation in the channel may impede flow and should be cleared.

Upstream view of Miles Creek from Reilly Rd. crossing. Summer 2017

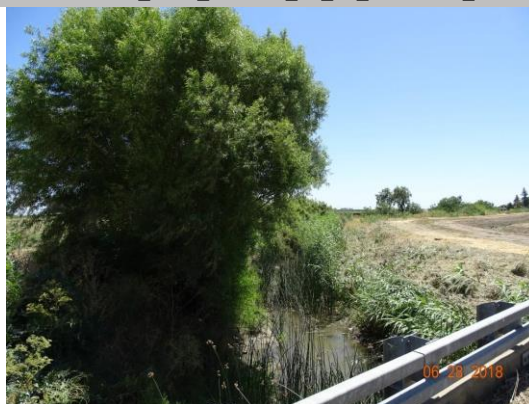
Photo 1 of 3 : CH_2018_NA0013_36_96_20180713_00064.jpg

Rating **	U	Issue No.	96	GPS Lat/Long
Issue Type +	Ma	Location *		37.257780 °
Category	Rivers, Channels & Designated Flood			-120.475090 °
Item	Vegetation & Obstructions			
DWR ID	DWR_NA0013_36_c_2012_96			
Action/Comments				
Inspector Comments: Some Arundo has been removed, but there is more growth that needs to be cleared.

View of vegetation in the channel. Summer 2018

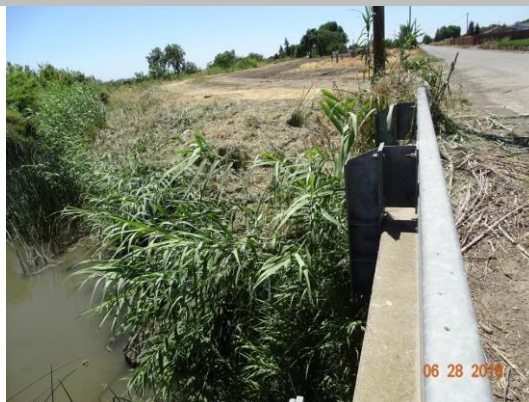
Photo 2 of 3 : CH_2018_NA0013_36_96_20180713_00066.jpg

Inspector Comments: Some Arundo has been removed, but there is more growth that needs to be cleared.

View of Arundo adjacent to the bridge. Summer 2018

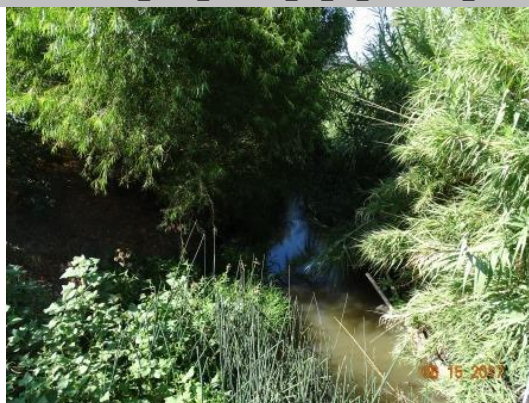
Photo 3 of 3 : CH_2018_NA0013_36_96_20180608_00024.jpg

Downstream view Miles Creek from Reilly Rd. crossing. Summer 2017

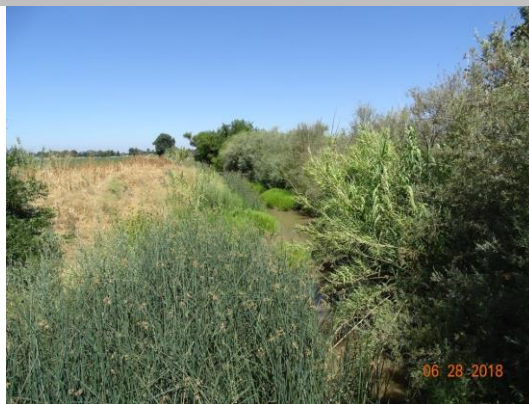
Photo 1 of 2 : CH_2018_NA0013_36_101_20180713_00067.jpg

Rating **	U	Issue No.	101	GPS Lat/Long
Issue Type +	Ma	Location *		37.255920 °
Category	Rivers, Channels & Designated Flood			-120.487940 °
Item	Vegetation & Obstructions			
DWR ID	DWR_NA0013_36_c_2012_101			
Action/Comments				
Inspector Comments: Woody vegetation and arundo in the channel may impede flow.

Arundo and woody vegetation may impede flow and need to be cleared.
Summer 2018

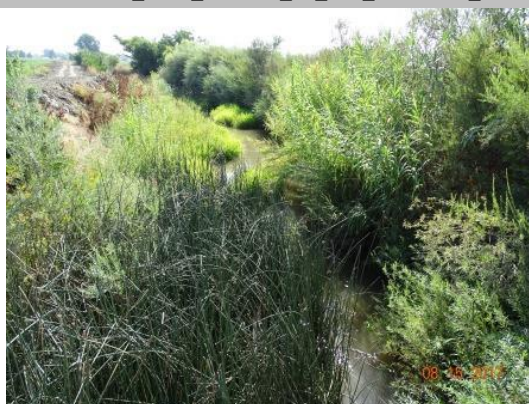
Photo 2 of 2 : CH_2018_NA0013_36_101_20180608_00025.jpg

Upstream view of Miles Creek from Highway 59 crossing. Summer 2017

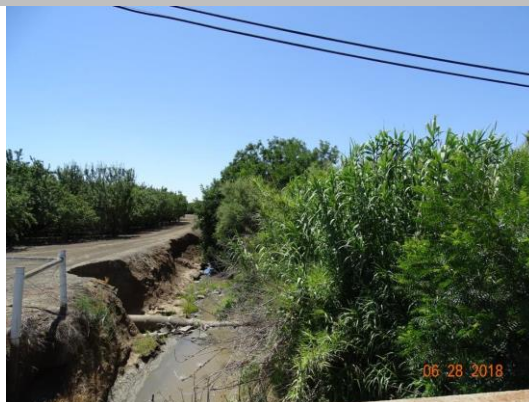
Photo 1 of 2 : CH_2018_NA0013_36_106_20180713_00068.jpg

Rating **	U	Issue No.	106	GPS Lat/Long
Issue Type +	Ma	Location *		37.255886 °
Category	Rivers, Channels & Designated Flood			-120.487970 °
Item	Vegetation & Obstructions			
DWR ID	DWR_NA0013_36_c_2012_106			
Action/Comments				
Inspector Comments: Arundo and woody vegetation may impede flow and need to be controlled or removed.

View of Arundo and other woody vegetation in the channel. Summer 2018

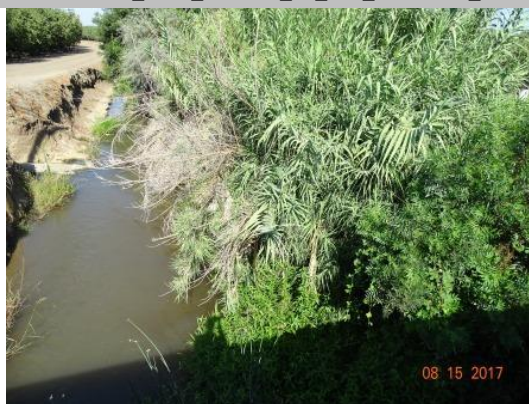
Photo 2 of 2 : CH_2018_NA0013_36_106_20180608_00027.jpg

Downstream view of Miles Creek from Highway 59 crossing. Summer 2017

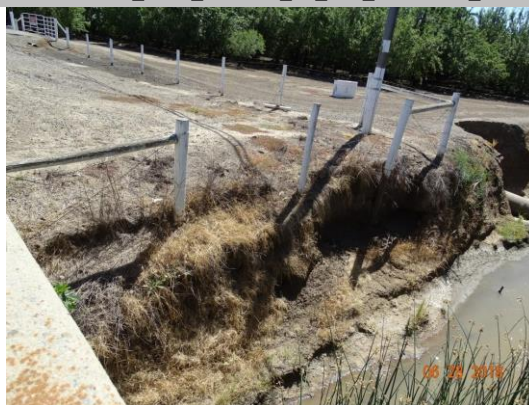
Photo 2 of 3 : CH_2018_NA0013_36_108_20180713_00070.jpg

Rating **	U	Issue No.	108	GPS Lat/Long
Issue Type +	Ma	Location *		37.255886 °
Category	Rivers, Channels & Designated Flood			-120.487970 °
Item	Erosion / Bank Caving			
DWR ID	DWR_NA0013_36_c_2012_108			
Action/Comments				
Inspector Comments: Erosion on the left bank may be due to the overgrown woody vegetation on the right bank. The bank should be repaired, and the woody vegetation should be cleared.

View of erosion on the left bank. Summer 2018

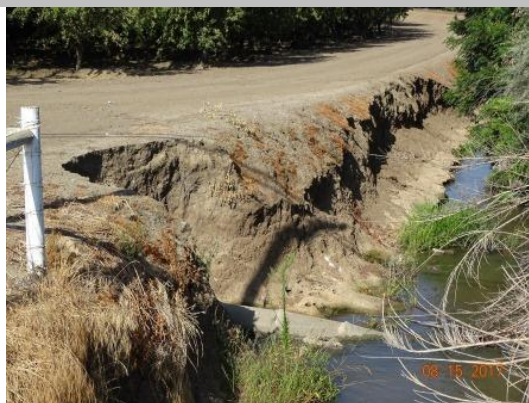
Photo 3 of 3 : CH_2018_NA0013_36_108_20180608_00028.jpg

View of the eroding channel bank. Summer 2017

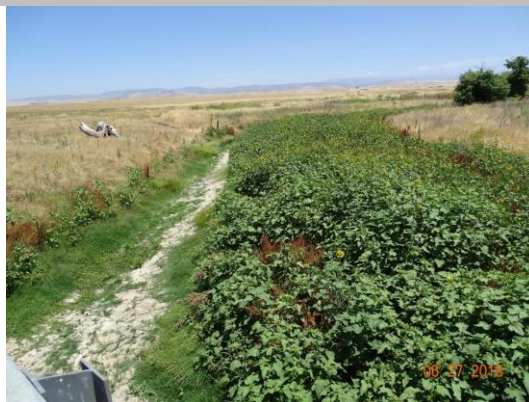
Photo 1 of 2 : CH_2018_NA0013_37_1_20180710_00014.jpg

Inspector Comments: Vegetation within the channel is growing. The large log identified in the previous inspection appears to have been removed or dislodged from the bridge.

View of growing vegetation in channel. Summer 2018

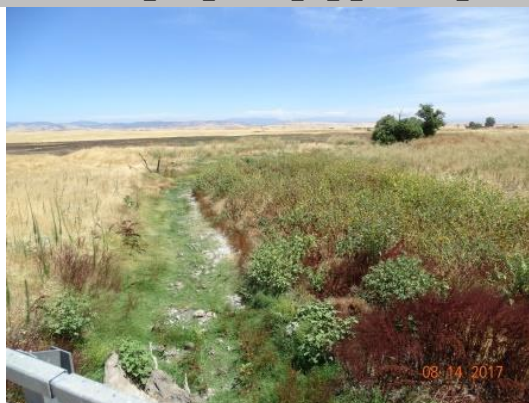
Photo 2 of 2 : CH_2018_NA0013_37_1_20180608_00001.jpg

Upstream view from Cunningham Road crossing. Summer 2017

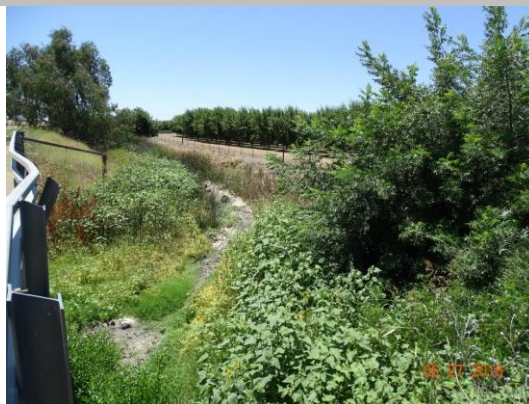
Photo 1 of 2 : CH_2018_NA0013_37_6_20180710_00015.jpg

Rating **	A	Issue No.	6	GPS Lat/Long
Issue Type +	Ma	Location *		37.289408 °
Category	Rivers, Channels & Designated Flood			-120.251939 °
Item	Vegetation & Obstructions			
DWR ID	DWR_NA0013_37_c_2012_6			
Action/Comments				
Inspector Comments: Vegetation in channel should be maintained.

View of growing vegetation in channel. Summer 2018

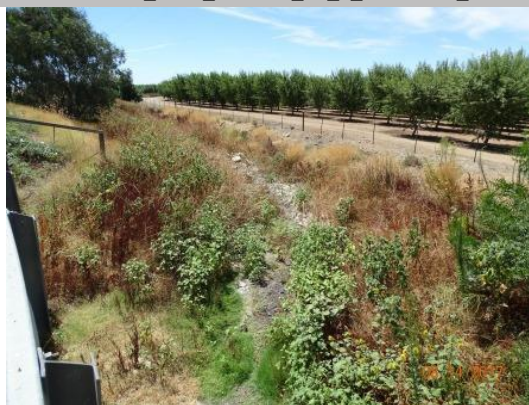
Photo 2 of 2 : CH_2018_NA0013_37_6_20180608_00003.jpg

Cunningham crossing downstream view. Summer 2017

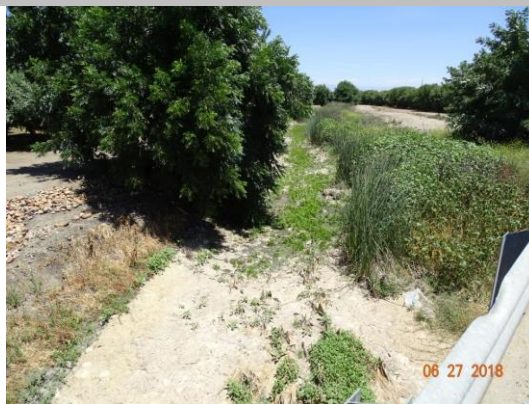
Photo 1 of 3 : CH_2018_NA0013_37_11_20180711_00028.jpg

Rating **	M	Issue No.	11	GPS Lat/Long
Issue Type +	Ma	Location *		37.287303 °
Category	Rivers, Channels & Designated Flood			-120.254863 °
Item	Vegetation & Obstructions			
DWR ID	DWR_NA0013_37_c_2012_11			
Action/Comments				
Inspector Comments: Vegetation and logs in the channel may be enough to impede flows and should be controlled or removed from the channel.

View of vegetation in the channel. Summer 2018

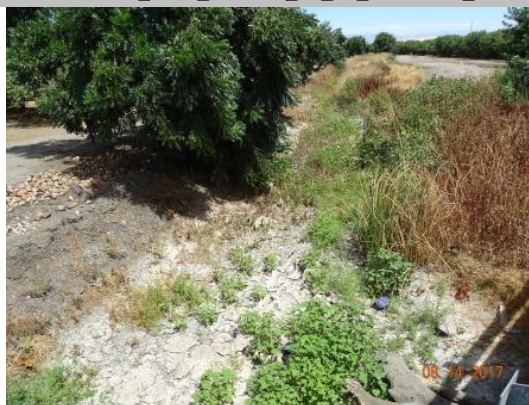
Photo 2 of 3 : CH_2018_NA0013_37_11_20180608_00004.jpg

Upstream view of Childs Ave. crossing. Summer 2017

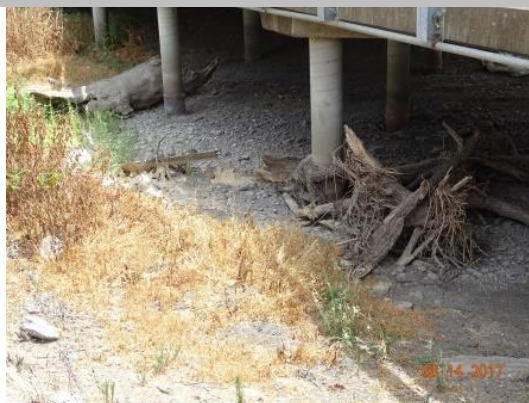
Photo 3 of 3 : CH_2018_NA0013_37_11_20180608_00005.jpg

View of the debris under the bridge. Summer 2017

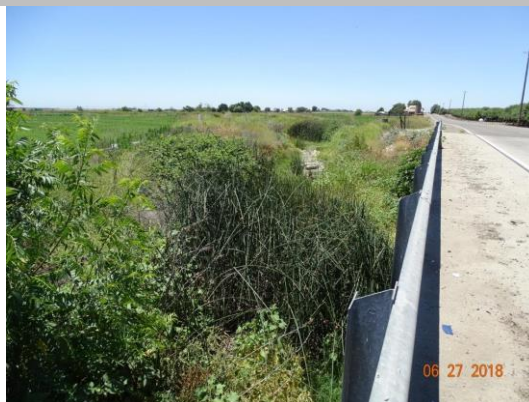
Photo 1 of 2 : CH_2018_NA0013_37_16_20180710_00016.jpg

Rating **	M	Issue No.	16	GPS Lat/Long
Issue Type +	Ma	Location *		37.287303 °
Category	Rivers, Channels & Designated Flood			-120.254863 °
Item	Vegetation & Obstructions			
DWR ID	DWR_NA0013_37_c_2012_16			
Action/Comments				
Inspector Comments: The vegetation in the channel may impeded flows and needs to be controlled or removed. A fig tree is establishing under the bridge and should be removed.

Growing vegetation in channel. Summer 2018

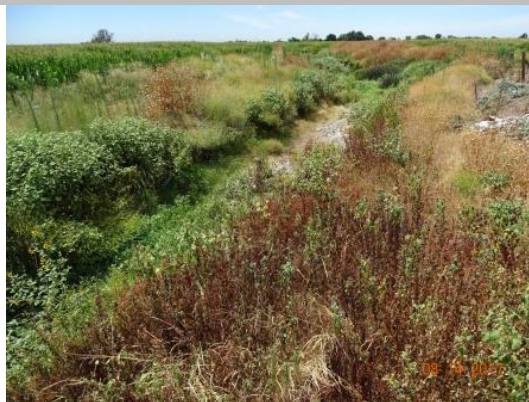
Photo 2 of 2 : CH_2018_NA0013_37_16_20180608_00006.jpg

View of downstream channel at Childs Ave. Summer 2017

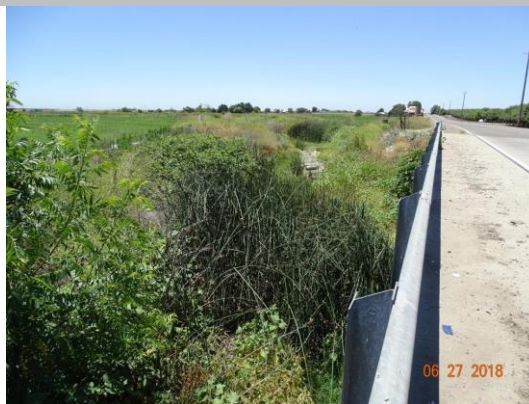
Photo 1 of 1 : CH_2018_NA0013_37_20_20180711_00017.jpg

Inspector Comments: Tires and a pallet need to be removed from the channel.

View of tire and pallet in channel. Summer 2018

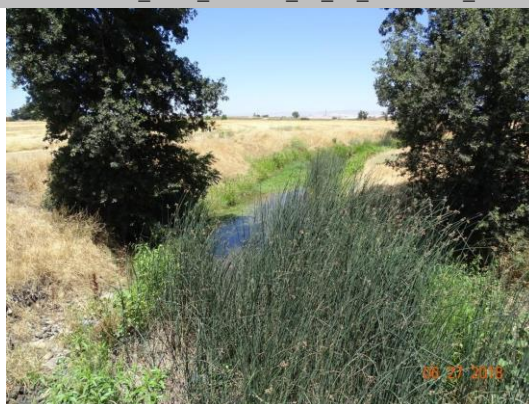
Photo 1 of 2 : CH_2018_NA0013_37_21_20180711_00018.jpg

View of growing vegetation in channel. Summer 2018

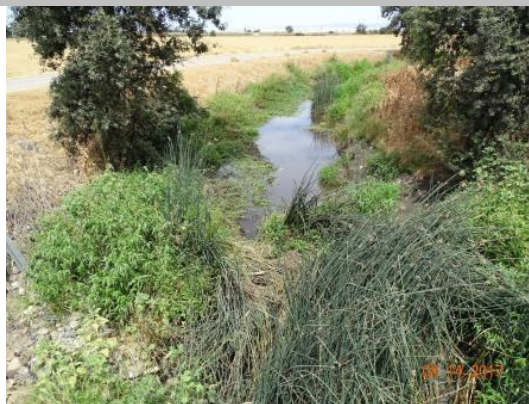
Photo 2 of 2 : CH_2018_NA0013_37_21_20180608_00007.jpg

Upstream view of Owens Creek from Mission Ave. crossing. Summer 2017

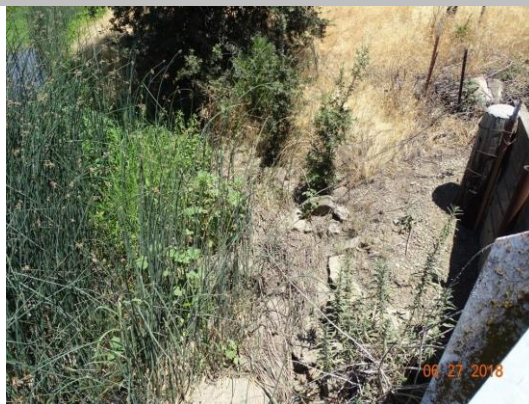
Photo 1 of 2 : CH_2018_NA0013_37_24_20180711_00019.jpg

View of sparse riprap on left bank. Summer 2018

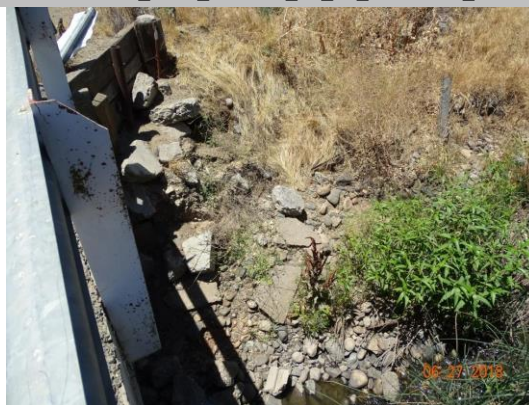
Photo 2 of 2 : CH_2018_NA0013_37_24_20180711_00020.jpg

View of visible riprap on right bank. Summer 2018

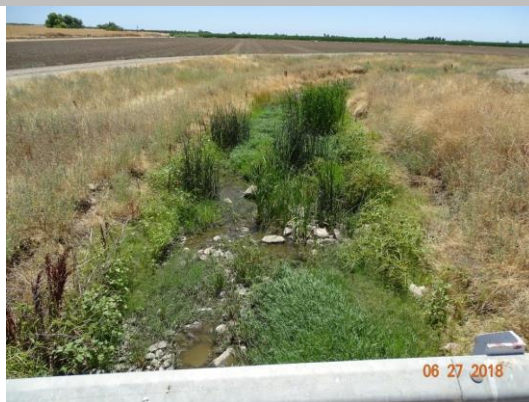
Photo 1 of 2 : CH_2018_NA0013_37_26_20180711_00021.jpg

Inspector Comments: There is minor vegetation, but it does not appear to be enough to impede flow.

View of growing vegetation in channel. Summer 2018

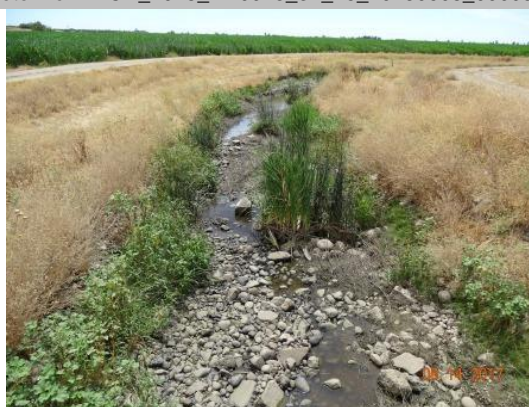
Photo 2 of 2 : CH_2018_NA0013_37_26_20180608_00008.jpg

Downstream view of Owens Creek from Mission Ave. crossing. Summer 2017

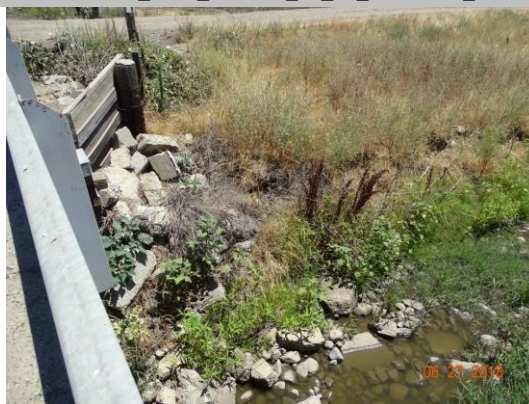
Photo 1 of 3 : CH_2018_NA0013_37_29_20180711_00023.jpg

Inspector Comments: Riprap has been placed in the channel at its most constricting point, beneath the bridge, this may reduce the flow capacity of the channel. The riprap along the channel is visible.

View of riprap on left bank. Summer 2018

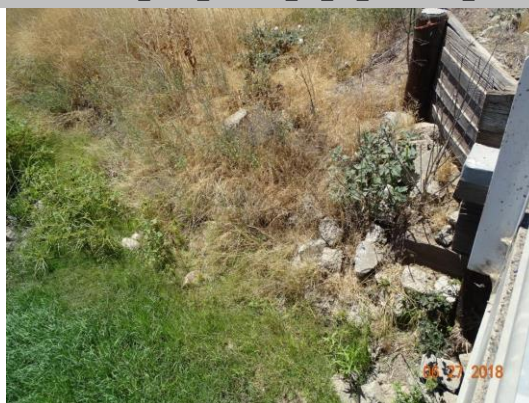
Photo 2 of 3 : CH_2018_NA0013_37_29_20180711_00024.jpg

View of riprap on right bank. Summer 2018

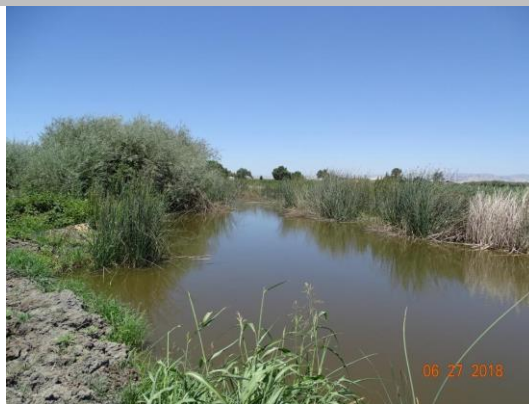
Photo 1 of 3 : CH_2018_NA0013_37_31_20180711_00025.jpg

View of minimal vegetation in channel. Summer 2018

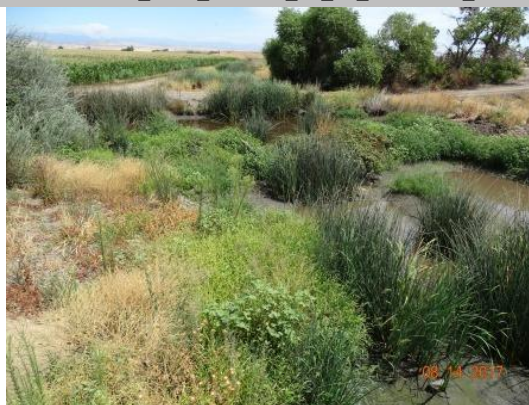
Photo 2 of 3 : CH_2018_NA0013_37_31_20180608_00010.jpg

Upstream view of Owens Creek at diversion. Summer 2017

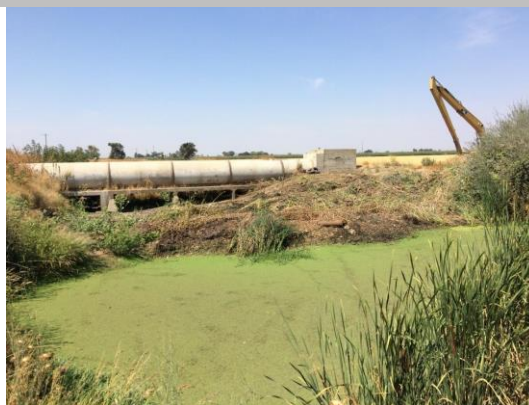
Photo 3 of 3 : CH_2018_NA0013_37_31_20180608_00011.jpg

View of the cleared vegetation at the upstream side of the checkpoint.
Note the earth dam which is removed by the farmer before flood season. Summer 2017

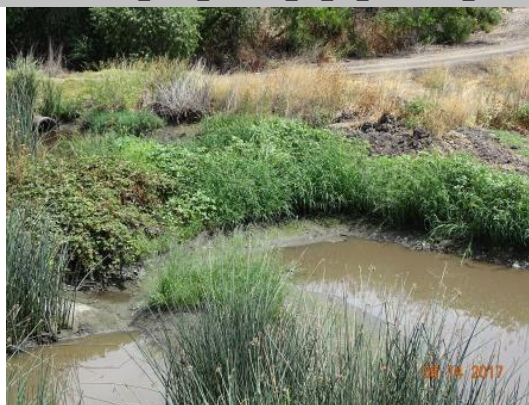
Photo 2 of 2 : CH_2018_NA0013_37_35_20180608_00012.jpg

Photo shows what appears to be material placed in the channel, material is overgrown with vegetation. Summer 2017

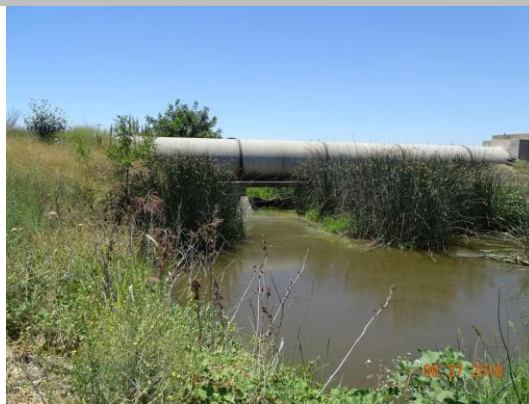
Photo 1 of 2 : CH_2018_NA0013_37_36_20180711_00027.jpg

Rating **	A	Issue No.	36	GPS Lat/Long
Issue Type +	Ma	Location *		37.273619 °
Category	Rivers, Channels & Designated Flood			-120.277469 °
Item	Vegetation & Obstructions			
DWR ID	DWR_NA0013_37_c_2012_36			
Action/Comments				
Inspector Comments: There is minimal vegetation in the channel, but it does not appear to impede flows.

View of minor vegetation along channel. Summer 2018

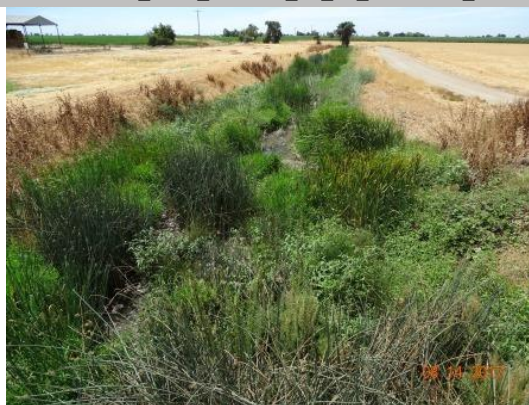
Photo 2 of 2 : CH_2018_NA0013_37_36_20180608_00013.jpg

Downstream view of Owens Creek from the diversion. Summer 2017
